THIRD ASSESSMENT OF WATER QUALITY IN THE SUSQUEHANNA RIVER BASIN

SUSQUEHANNA RIVER BASIN COMMISSION

RESOURCE QUALITY MANAGEMENT & PROTECTION DIVISION

OCTOBER 1987

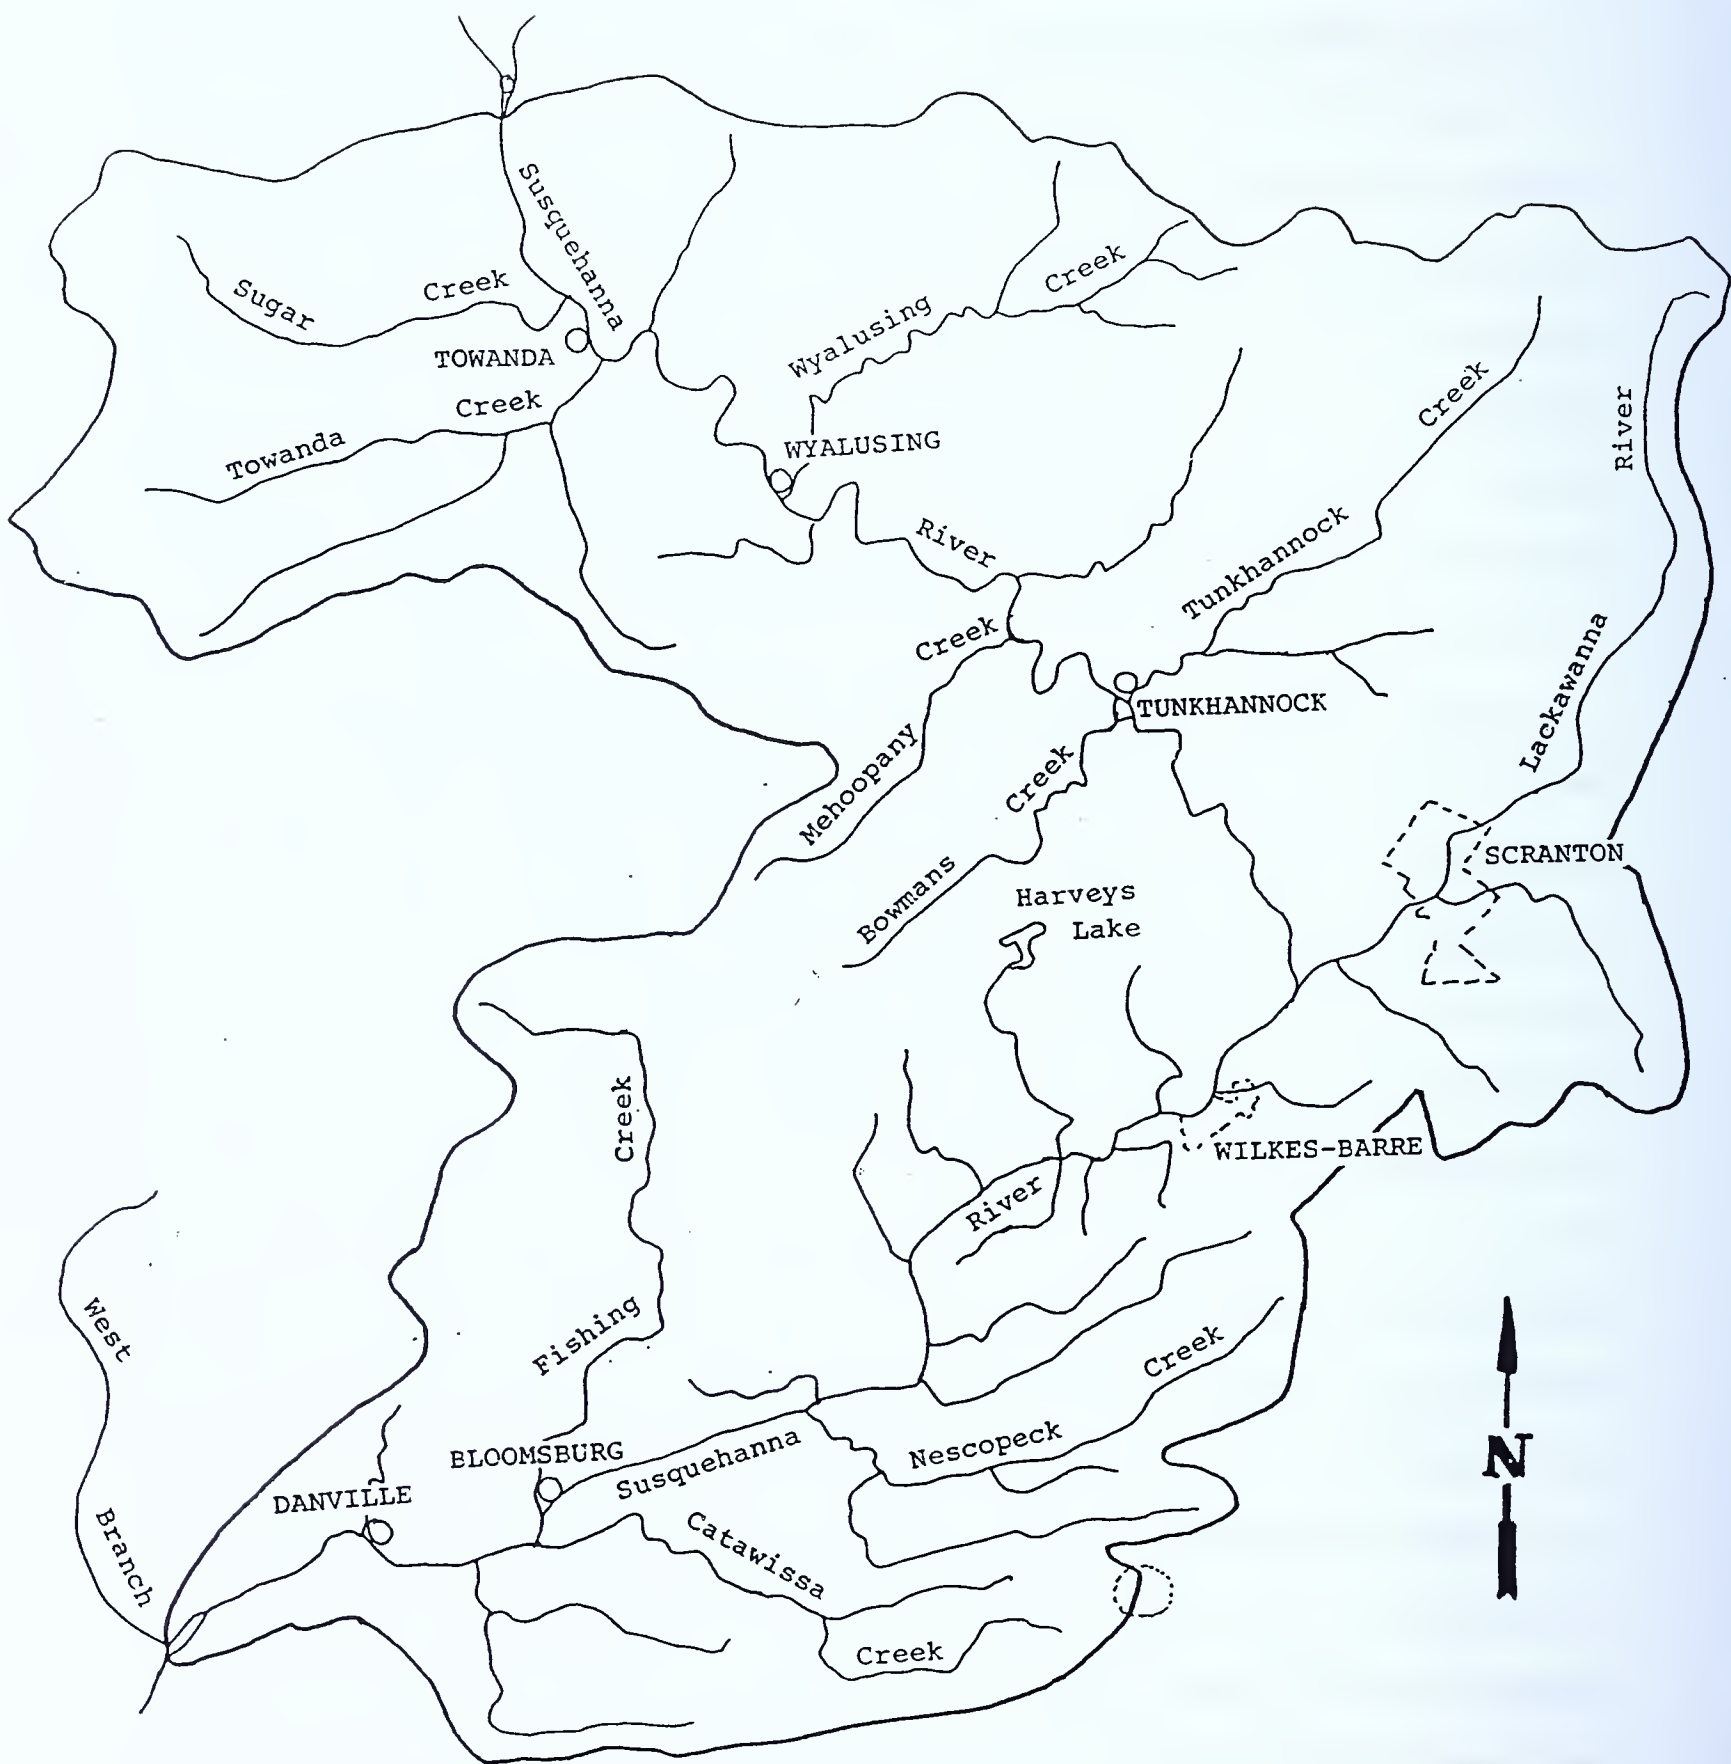
FIGURE 12 - UPPER SUSQUEHANNA SUBBASIN

This subbasin includes the area drained by the Susquehanna River between its confluences with the Chemung River and the West Branch Susquehanna River (Figure 12). The Chemung and Susquehanna Rivers upstream of this subbasin both have good water quality although high bacteria concentrations have been observed indicating poor treatment of domestic wastes and agricultural runoff problems. This does not seem to impact the quality of the Susquehanna River because fish and macroinvertebrate communities are healthy.
